Rocky cliff landslide hazard: the Capo Noli Promontory case study (western Liguria, NW Mediterranean Sea)

Document type: Extended Abstract.

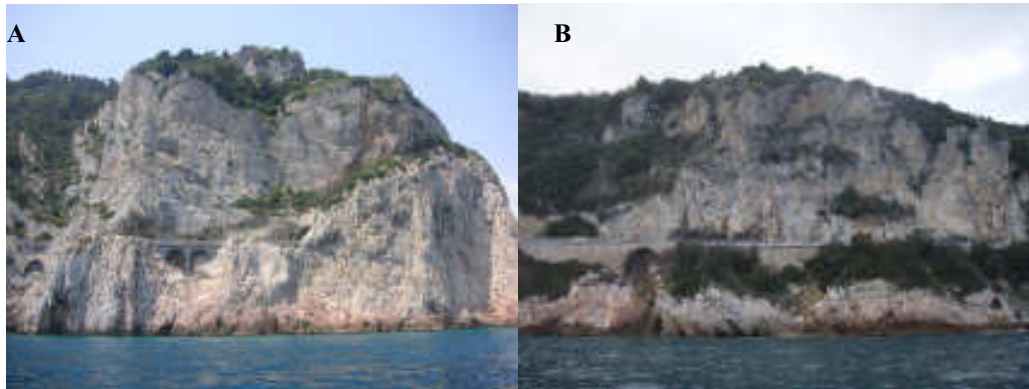
Fig. 2 – The Capo Noli Promontory rocky plunging cliffs: A) NE-SW trending section; B) NW-SE trending section.

Surveys have been carried out on two main cliff zones with different orientations which are, from west to east: a NE-SW trending section (at the 591+100 progressive milestone) exposed to SE (Fig. 2) and the NW-SE trending section (between 591+700 and 591+800 progressive milestones). The cliff heights range from 50 to 90 m with slope angles ranging from 80° to vertical. Less inclined zones near the cliff top suggest the presence of relicts of wave-cut terraces. The rocky cliffs are not urbanized with the exception of the existing coastal road (“Aurelia” State Road n.1) built in the early 1880s by the Napoleonic Empire. Consequently, although the rocky cliffs suffer slight wave erosion below the road, the magnitude of the hazard depends on rock mass mechanical quality and geometric relationship between joint sets and plunging cliffs. The landslides occurring on the promontory of Capo Noli (Liguria Region, NW Mediterranean Sea) on the 16th of January 2008 and on the 29th of February 2009 have resulted in the shutdown of the main road for several months leading to considerable inconveniences concerning economic and tourist activities (Fig. 3). Sudden rockfalls occurred from heights of about 20 and 40m along the vertical rock faces, tearing rockfall nets and support cables.

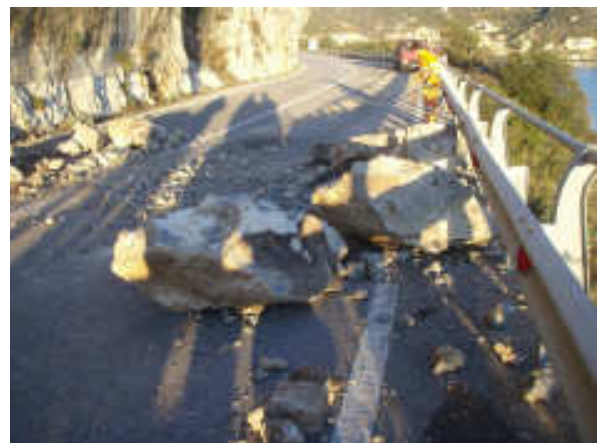
Fig. 3 – Rockfall affecting the Capo Noli cliffs on 16 January 2008.

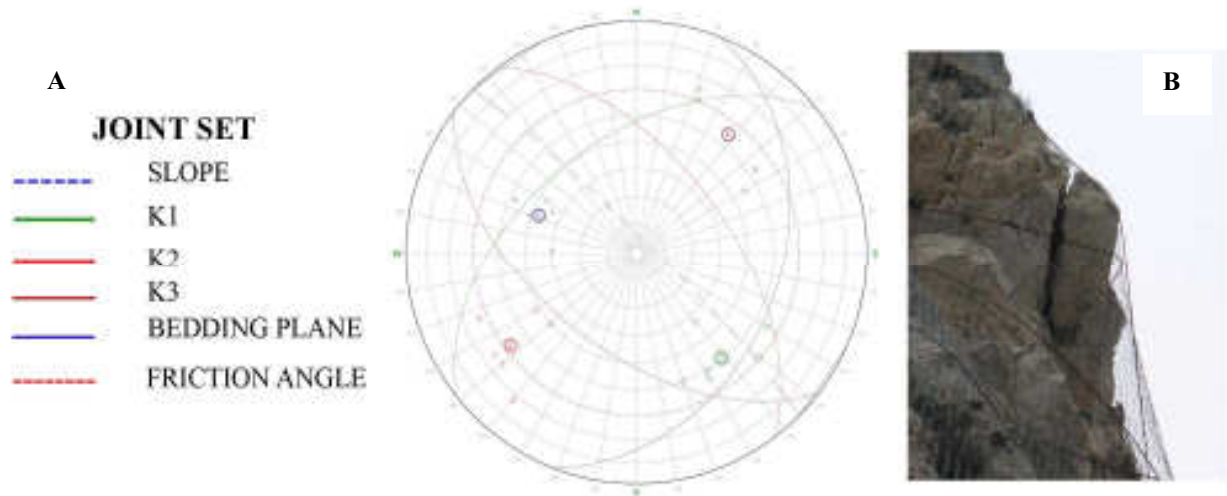
Fig. 4 –Geo-mechanical survey of the study area: A) joint sets detected and Markland's test; B) toppling affecting the rocky plunging cliffs.

The orientation data (Fig. 4) show that the attitude of bedding planes is always more or less normal to the direction of the slope: the trend of the NE-SW section displays dip directions ranging between 340° and 135° while a 92° and 114° trend range was detected in the NW-SE section. The measured dips are very variable, ranging between 45° and 70° . Numerous measured joints have been grouped into three sets (K1-K3). With regards to the potential instabilities, cyclographic

projections of some sets respect to the slope, suggest the possible occurrence of toppling and wedge slide. Topples occur along very steep bedding surfaces, the orientations of which are nearly parallel to the slope, intersected by dipping joints of opposite plunge. However, rockfalls are the most likely failure mechanism to occur due to the highly fractured plunging cliffs just above the main road. In fact, due to the high steep or vertical slopes, phenomena such as toppling or slide wedge failure quickly evolve into rockfalls.

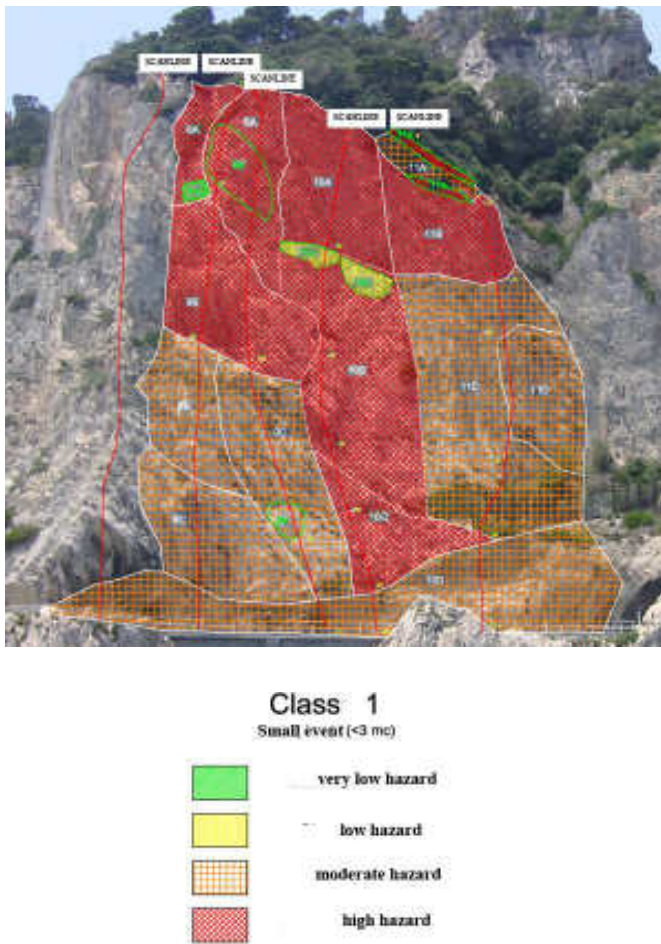
Fig. 5 –Landslide hazard zonation with respect class 1 events.

Results of this study defined the most potential failure geometries and the hazard landslide zonation of two Capo Noli plunging cliff sections. Both bedding planes and joints geometrical and mechanical properties, such as high bedding surface continuity, the orientation of which is nearly parallel to the slope, mutually intersected by joints with opposite plunge, lead to rockfalls and toppling. Generally, this is possible mainly in poorly interlocking rock mass portions, with very open joints. Intersection of joint sets can sometimes form wedge instability, which however instantly evolves into rolling, rebounding and rockfalls. Consequently, the above presented structural and mechanical rock mass layout has allowed to establish four hazard zone classes depending on different potential instable rock volumes: class 1 (small events-less than 3 m^3), class 2 (moderate events-between 3 and 10 m^3), class 3 (significant events-between 30 - 300 m^3), class 4 (extreme events-greater than 300 m^3). Based on direct observations, within each class a probability scale has been assigned. In the study area the hazard analysis shows that the highest landslide susceptibility is related to class 1 and class 2 events (Fig. 5). This is in agreement with the rock mass geometrical and
